UCC Gaol Wall Portico

Completed 2017

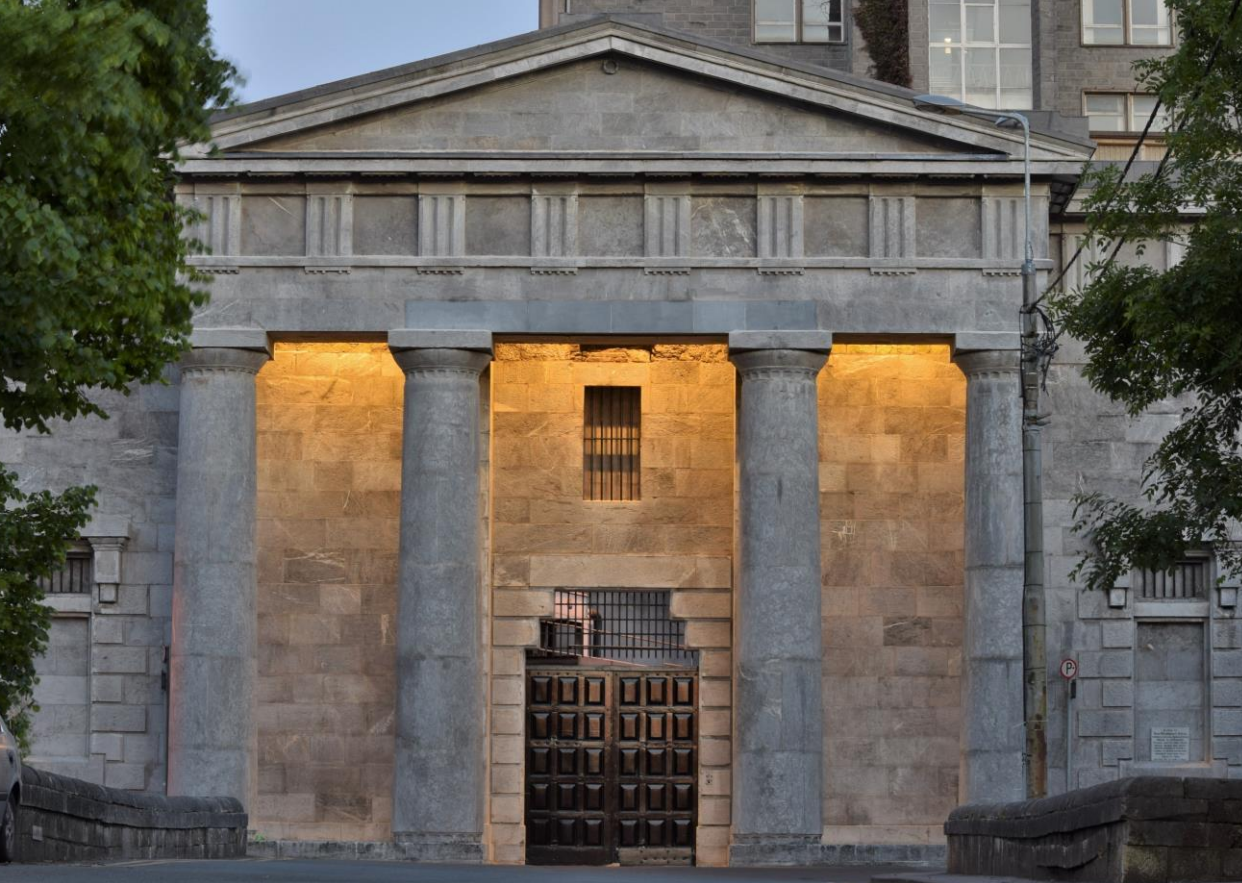
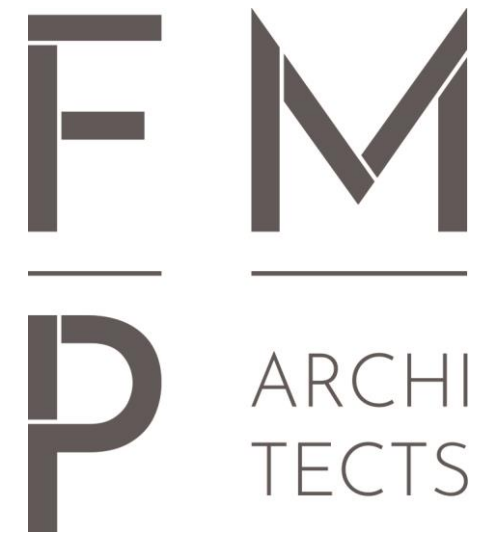
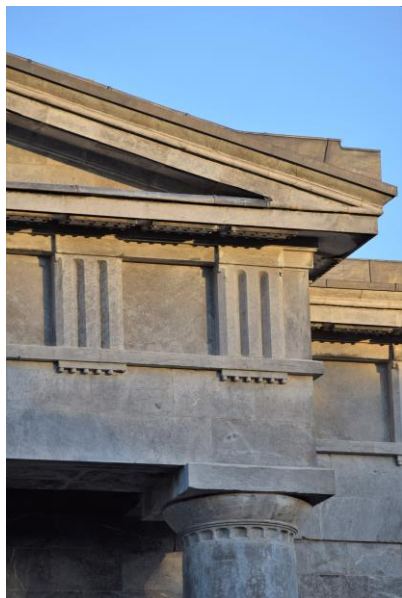
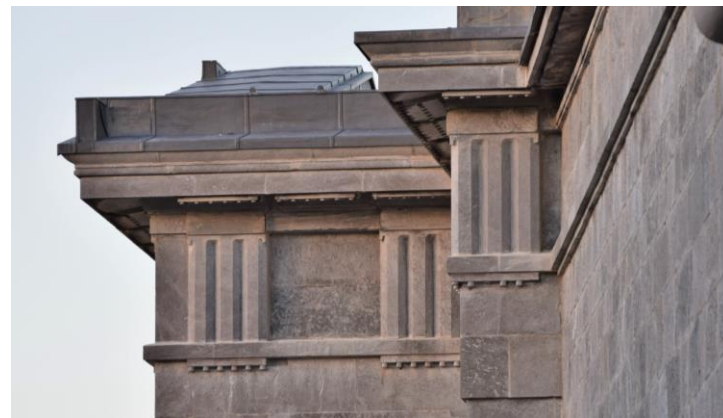
The wall which is constructed of cut limestone had simply acted as a boundary wall for many years and had reached the point where water penetration and vegetation were threatening the stability of the structure.

The work involved the removal and reseating of the first three to four coping stones. Vegetation was carefully removed from the vertical and horizontal faces of the wall. The joints were repointed in a specialist lime mortar. Successful repairs were carried out to sections of the stone work itself and the weather-protecting lead work.

Additionally, a considerable amount of structural and support work took place in the portico area and to projecting stone elements.
